Manhole Inspection Summary

Manhole # S03GG2002MH

Insp Date: **10/10/06 2:09 PM**

Location Address: **2929 FALLSTAFF RD**

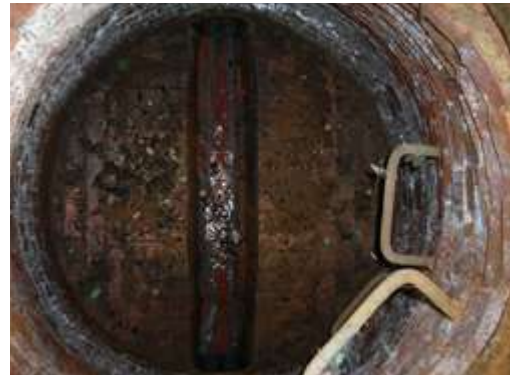
Top View

Frame offset. Adjustment deterioration and infiltration. Corbel and Barrel infiltration. Evidence of surcharge - Bench

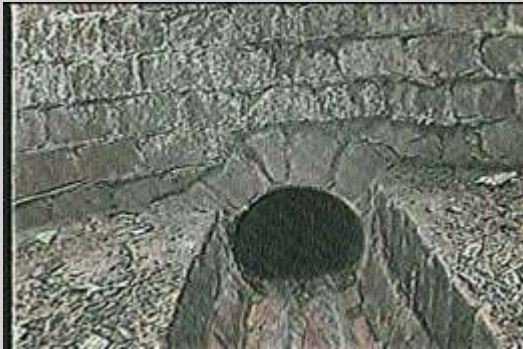
Pipe Out @ 12 O'Clock

Barrel deterioration and infiltration. Channel deterioration.

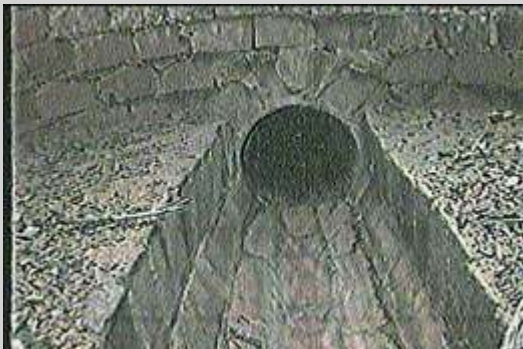
Pipe In @ 6 O'Clock

Barrel deterioration and infiltration. Channel deterioration.
